INLET INSPECTION

INLET ID: #201 Intersection Knollview + Carpentersville Road

DATE OF INSPECTION: 1-30-23

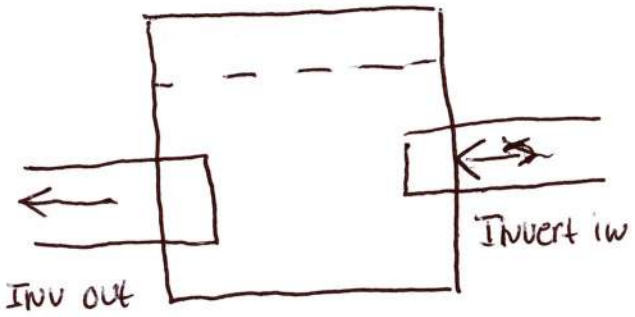
Newly Reconstructed Inlet

IS THERE A BENCH FOR DIRECTING FLOW: Yes

CONDITION OF BENCH: (NEW) ACCEPTABLE NEEDS REPAIR

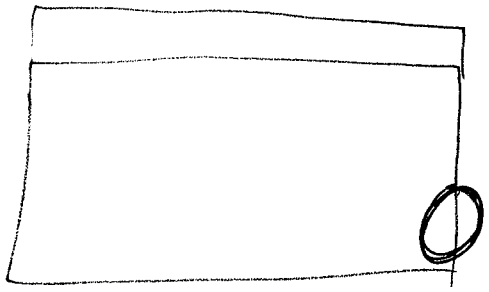
CONTINUE - LEVEL 2 INSPECTION (INTERIOR DETAILED INSPECTION)
CURB PIECE INFORMATION
TYPE OF CURB PIECE
HEIGHT OF CURB PIECE 6"
CONDITION OF CURB PIECE: NEW (ACCEPTABLE) NEEDS REPLACEMENT
CURB PIECE ECO HEAD TYPE: (BAR) PLATE FULL ECO CURB PIECE
LABEL FOR DRAINS TO WATERWAYS STAMPED ON BAR
WATERWAYS LABEL CONDITION: NEW (ACCEPTABLE) NEEDS REPLACEMENT
ADDITIONAL CURB PIECE COMMENTS (DESCRIBE DAMAGE, ISSUES)
INTERIOR STRUCTURE INFORMATION
STRUCTURE INTERIOR MEASUREMENTS:
WALL CONSTRUCTION MATERIAL TYPE:
WALL CONDITION: NEW ACCEPTABLE NEEDS REPAIR NEEDS REPLACEMENT
CONDITION OF JOINTS: NEW ACCEPTABLE NEEDS REPAIR NEEDS REPLACEMENT NO JOINTS
CONDITION OF LEVELING BLOCKS: NEW ACCEPTABLE NEEDS REPAIR NEEDS REPLACEMENT
LADDER RUNGS: NEW ACCEPTABLE NEEDS REPAIR NEEDS REPLACEMENT NONE
SUMP CONDITION: NEW ACCEPTABLE NEEDS REPAIR NEEDS REPLACEMENT
ADDITIONAL STRUCTURE COMMENTS: UNABLE TO INSPECT INTERIOR AT THIS TIME.

IS THERE A BENCH FOR DIRECTING FLOW: NONE OBSERVED

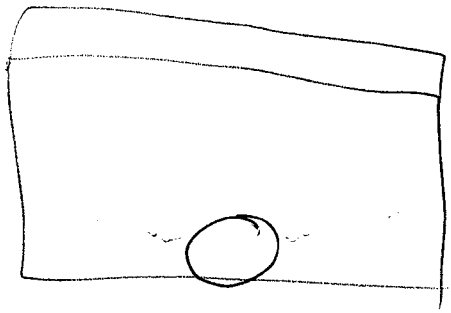
CONTINUE - LEVEL 2 INSPECTION (INTERIOR DETAILED INSPECTION)
CURB PIECE INFORMATION
TYPE OF CURB PIECE
HEIGHT OF CURB PIECE 6"
CONDITION OF CURB PIECE: NEW (ACCEPTABLE) NEEDS REPLACEMENT
CURB PIECE ECO HEAD TYPE: (BAR) PLATE FULL ECO CURB PIECE
LABEL FOR DRAINS TO WATERWAYS STAMPED ON BAR
WATERWAYS LABEL CONDITION: NEW (ACCEPTABLE) NEEDS REPLACEMENT
ADDITIONAL CURB PIECE COMMENTS (DESCRIBE DAMAGE, ISSUES)
INTERIOR STRUCTURE INFORMATION
STRUCTURE INTERIOR MEASUREMENTS:
WALL CONSTRUCTION MATERIAL TYPE:
WALL CONDITION: NEW ACCEPTABLE NEEDS REPAIR NEEDS REPLACEMENT
CONDITION OF JOINTS: NEW ACCEPTABLE NEEDS REPAIR NEEDS REPLACEMENT NO JOINTS
CONDITION OF LEVELING BLOCKS: NEW ACCEPTABLE NEEDS REPAIR NEEDS REPLACEMENT
LADDER RUNGS: NEW ACCEPTABLE NEEDS REPAIR NEEDS REPLACEMENT N/A - NONE
SUMP CONDITION: NEW ACCEPTABLE NEEDS REPAIR NEEDS REPLACEMENT
ADDITIONAL STRUCTURE COMMENTS: UNABLE TO INSPECT INTERIOR AT THIS TIME.

IS THERE A BENCH FOR DIRECTING FLOW: YES

CONDITION OF BENCH: NEW (ACCEPTABLE) NEEDS REPAIR

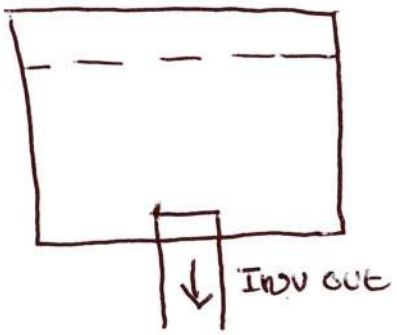
CONTINUE - LEVEL 2 INSPECTION (INTERIOR DETAILED INSPECTION)
CURB PIECE INFORMATION
TYPE OF CURB PIECE 6" ofew curb Piece
HEIGHT OF CURB PIECE 6"
CONDITION OF CURB PIECE: NEW (ACCEPTABLE) NEEDS REPLACEMENT
CURB PIECE ECO HEAD TYPE: BAR PLATE FULL ECO CURB PIECE
LABEL FOR DRAINS TO WATERWAYS Yes
WATERWAYS LABEL CONDITION: NEW (ACCEPTABLE) NEEDS REPLACEMENT
ADDITIONAL CURB PIECE COMMENTS (DESCRIBE DAMAGE, ISSUES) 6" ofew curb not ECO
INTERIOR STRUCTURE INFORMATION
STRUCTURE INTERIOR MEASUREMENTS: 42" x 48"
WALL CONSTRUCTION MATERIAL TYPE: Block
WALL CONDITION: NEW ACCEPTABLE (NEEDS REPAIR) NEEDS REPLACEMENT
CONDITION OF JOINTS: NEW ACCEPTABLE (NEEDS REPAIR) NEEDS REPLACEMENT NO JOINTS
CONDITION OF LEVELING BLOCKS: NEW ACCEPTABLE (NEEDS REPAIR) NEEDS REPLACEMENT
LADDER RUNGS: NEW ACCEPTABLE NEEDS REPAIR NEEDS REPLACEMENT Shallow
SUMP CONDITION: NEW (ACCEPTABLE) NEEDS REPAIR NEEDS REPLACEMENT
ADDITIONAL STRUCTURE COMMENTS: Inlet was repaired many years ago . needs some repairs - Blocks seperated

in Good condition

Inlet is in fair shape needs some repairs - seperated Block + Plaster coat

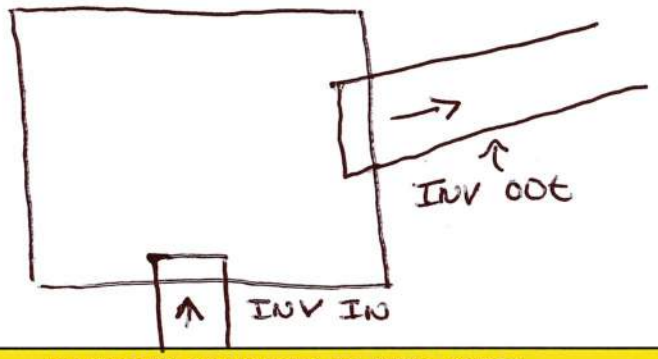
1 INV IN 15" RCP

in good condition

Inlet is in good condition

Inlet was repaired recently Needs Plaster coat
INTERIOR DEBRIS & FLOWS
DEBRIS PRESENT IN STRUCTURE: YES (NO)
AMOUNT OF DEBRIS REMOVED FROM INLET: DEPTH OF DEBRIS IN STRUCTURE OR CY (ESTIMATED)
HOW WAS DEBRIS REMOVED:
WHERE WAS DEBRIS DISPOSED OF:
FLOW DESCRIPTION: (NONE) TRICKLE MODERATE SUBSTANTIAL
ODOR DETECTED (DESCRIBE ODOR): no odor
WAS THERE PONDING OR WATER BUILD UP AT INLET: YES (NO)
ADDITIONAL COMMENTS: (DESCRIBE TYPE OF DEBRIS - LEAFS, HOUSEHOLD TRASH, SANITARY WASTE)

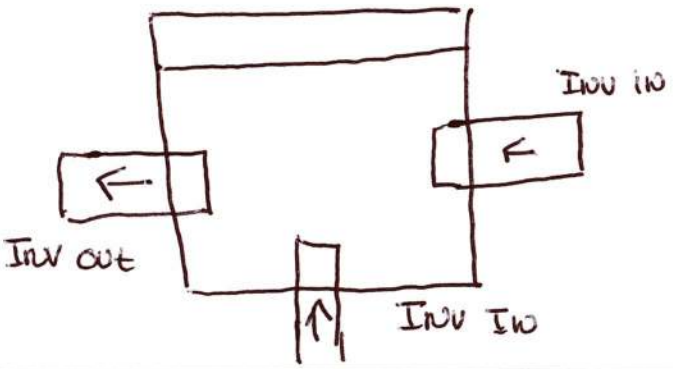
CONTINUE - LEVEL 2 INSPECTION (INTERIOR DETAILED INSPECTION)
CURB PIECE INFORMATION
TYPE OF CURB PIECE 6" open curb NOT ECO
HEIGHT OF CURB PIECE 6"
CONDITION OF CURB PIECE: NEW (ACCEPTABLE) NEEDS REPLACEMENT
CURB PIECE ECO HEAD TYPE: BAR PLATE FULL ECO CURB PIECE
LABEL FOR DRAINS TO WATERWAYS Yes
WATERWAYS LABEL CONDITION: NEW (ACCEPTABLE) NEEDS REPLACEMENT
ADDITIONAL CURB PIECE COMMENTS (DESCRIBE DAMAGE, ISSUES) 6" open curb Piece not ECO
INTERIOR STRUCTURE INFORMATION
STRUCTURE INTERIOR MEASUREMENTS: 42" x 48"
WALL CONSTRUCTION MATERIAL TYPE: Precast concrete
WALL CONDITION: NEW (ACCEPTABLE) NEEDS REPAIR NEEDS REPLACEMENT
CONDITION OF JOINTS: NEW (ACCEPTABLE) NEEDS REPAIR NEEDS REPLACEMENT NO JOINTS
CONDITION OF LEVELING BLOCKS: NEW (ACCEPTABLE) NEEDS REPAIR NEEDS REPLACEMENT
LADDER RUNGS: NEW (ACCEPTABLE) NEEDS REPAIR NEEDS REPLACEMENT
SUMP CONDITION: NEW (ACCEPTABLE) NEEDS REPAIR NEEDS REPLACEMENT
ADDITIONAL STRUCTURE COMMENTS: Inlet in good condition Plaster coat needed

Inlet in good condition

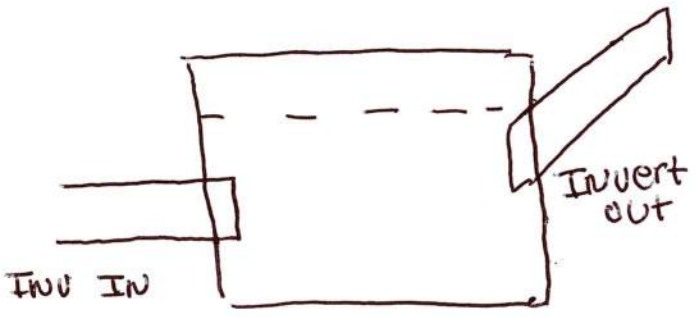
CONTINUE - LEVEL 2 INSPECTION (INTERIOR DETAILED INSPECTION)
CURB PIECE INFORMATION
TYPE OF CURB PIECE 6" offset curb
HEIGHT OF CURB PIECE 6"
CONDITION OF CURB PIECE: NEW (ACCEPTABLE) NEEDS REPLACEMENT
CURB PIECE ECO HEAD TYPE: BAR PLATE FULL ECO CURB PIECE
LABEL FOR DRAINS TO WATERWAYS Yes
WATERWAYS LABEL CONDITION: NEW (ACCEPTABLE) NEEDS REPLACEMENT
ADDITIONAL CURB PIECE COMMENTS (DESCRIBE DAMAGE, ISSUES) 6" offset curb not ECO
INTERIOR STRUCTURE INFORMATION
STRUCTURE INTERIOR MEASUREMENTS: 42" x 48"
WALL CONSTRUCTION MATERIAL TYPE: Precast concrete
WALL CONDITION: NEW (ACCEPTABLE) NEEDS REPAIR NEEDS REPLACEMENT
CONDITION OF JOINTS: NEW ACCEPTABLE (NEEDS REPAIR) NEEDS REPLACEMENT NO JOINTS
CONDITION OF LEVELING BLOCKS: NEW ACCEPTABLE NEEDS REPAIR (NEEDS REPLACEMENT)
LADDER RUNGS: NEW (ACCEPTABLE) NEEDS REPAIR NEEDS REPLACEMENT
SUMP CONDITION: NEW (ACCEPTABLE) NEEDS REPAIR NEEDS REPLACEMENT
ADDITIONAL STRUCTURE COMMENTS: Inlet leveling Blocks need repair

Good condition

Inlet leveling Blocks need replacement

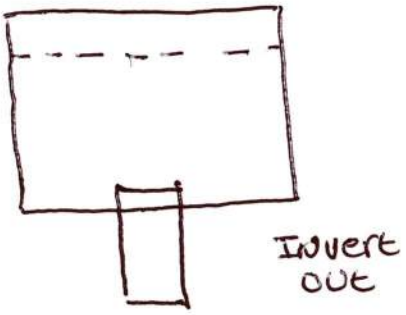
CONDITION OF LEVELING BLOCKS: NEW ACCEPTABLE NEEDS REPAIR (NEEDS REPLACEMENT)

Leveling Blocks need to be replaced

1 Invert out 15" RCP
in Good condition

Inlet needs leveling
Block repair

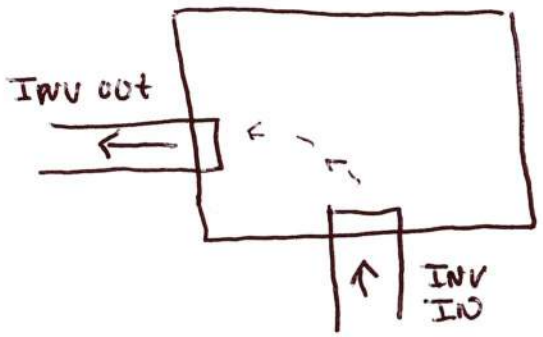
IS THERE A BENCH FOR DIRECTING FLOW: Yes

CONDITION OF BENCH: NEW (ACCEPTABLE) NEEDS REPAIR

1 Invert in - 15" RCP

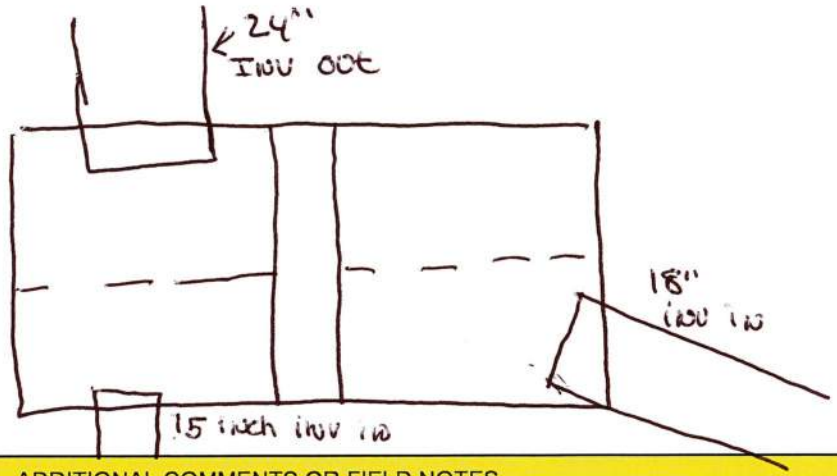
SKETCH OF PIPE CONNECTIONS

UNKNOWN OUTFLOW Possibly "24

Inlet Boxes Are in good condition - some Block leveling repairs needed

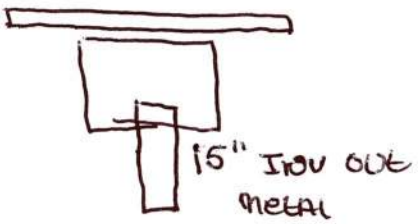
IS THERE A BENCH FOR DIRECTING FLOW: NO

CONDITION OF BENCH: NEW ACCEPTABLE (NEEDS REPAIR)

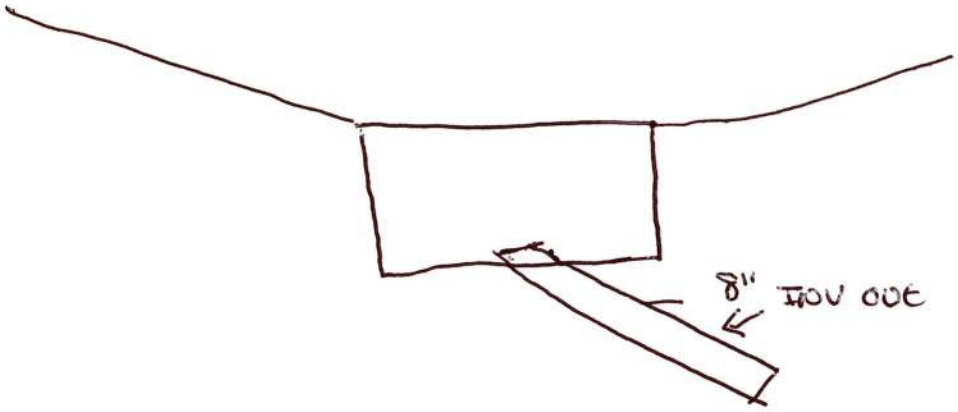
IS THERE A BENCH FOR DIRECTING FLOW: NO

CONDITION OF BENCH: NEW ACCEPTABLE (NEEDS REPAIR)

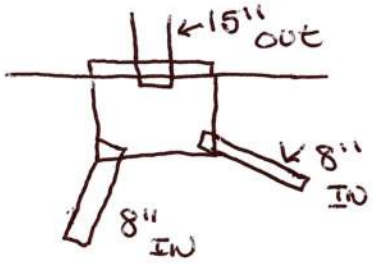
IS THERE A BENCH FOR DIRECTING FLOW: NO

CONDITION OF BENCH: NEW ACCEPTABLE (NEEDS REPAIR)

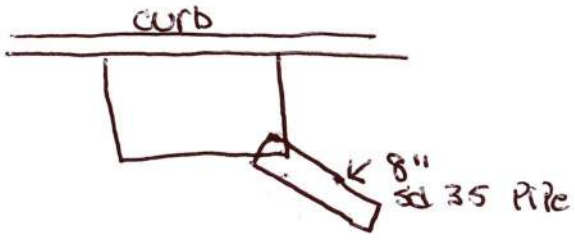
IS THERE A BENCH FOR DIRECTING FLOW: NO

CONDITION OF BENCH: NEW ACCEPTABLE (NEEDS REPAIR)
